# Aviation Investigation Preliminary Report

<b>Location:</b>	Chicago, IL	<b>Incident Number:</b>	DCA24LA318
<b>Date &amp; Time:</b>	September 25, 2024, 15:26 Local	<b>Registration:</b>	N772MR
<b>Aircraft:</b>	Embraer ERJ 170-100 LR	<b>Injuries:</b>	68 None
<b>Flight Conducted Under:</b>	Part 121: Air carrier - Scheduled

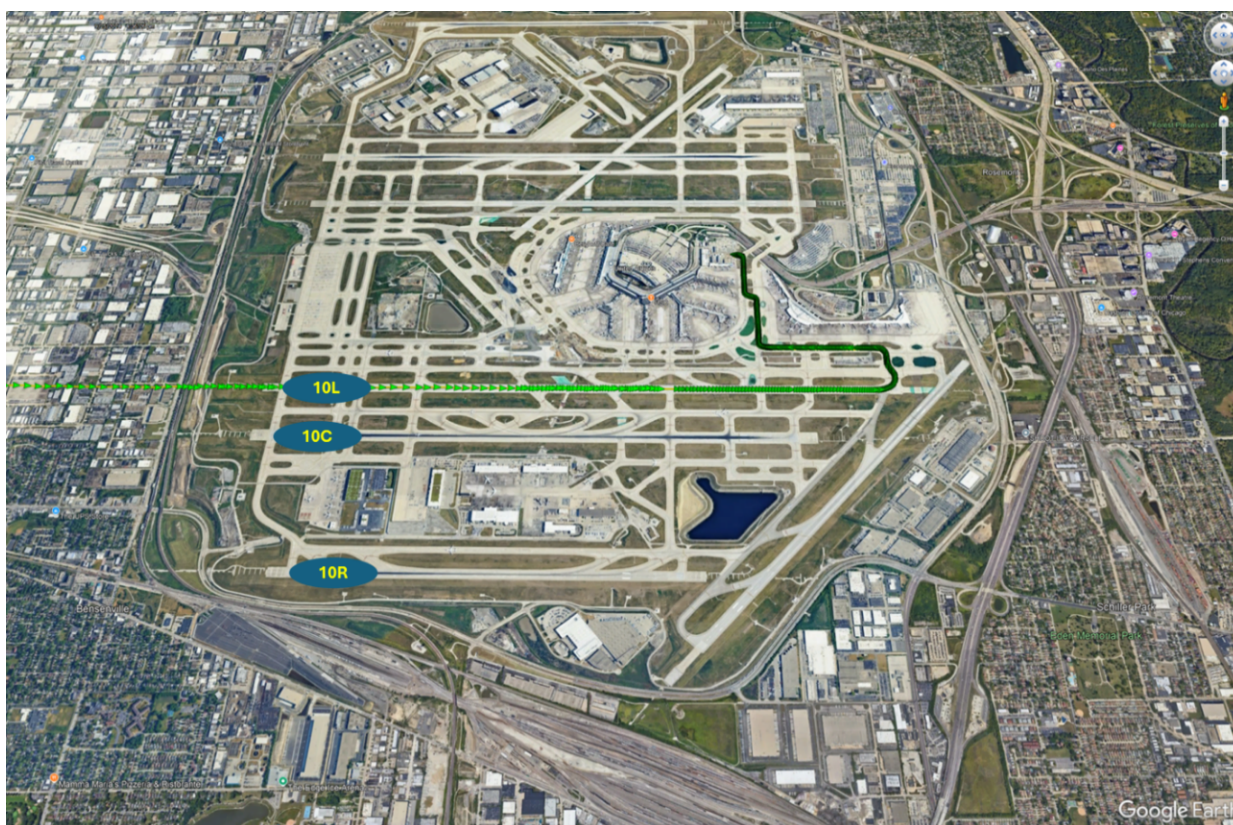
The captain contacted the air traffic control tower (ATCT) controller stating they were on the visual approach to runway 10C, and the airplane was cleared to land on runway 10C. However, the airplane was aligned with and landed on runway 10L. The airplane touched down at about 1526:25 CDT and turned left to exit the runway. The figure below is a Google Earth screenshot that is overlaid with automatic dependent surveillance-broadcast (ADS-B) ground track showing the incident flight aligned with and landing on runway 10L at ORD.

**Figure 1.** Google Earth screenshot that is overlaid with automatic dependent surveillance-broadcast (ADS-B) ground track showing the incident flight.
